*** The existing Toddler/Junior Playground**

Possible Locations For A New Natural Play Area

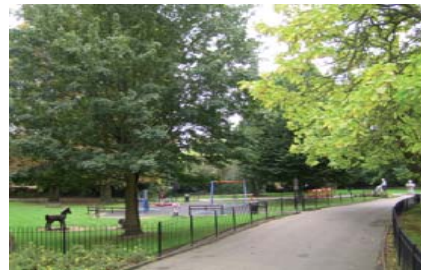
This is a small, fairly new playground located close to the Lower Pond and decked seating area, which offers a small selection of metal-based toddler and junior play equipment (up to age 6), set within rubberised play surfacing, enclosed by hoop top fencing. The playground is very well used, and at peak times children are seen queuing.

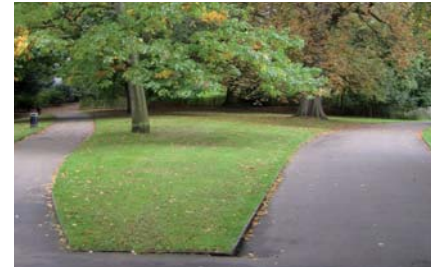
- 1. Location:** Grassy triangle with several mature trees, on gently sloping slope, immediately south of Upper Pond Nature Area
Appraisal: This is a very attractive site with several mature trees which would lend itself well to forming a natural play space. However siting a physically challenging play area in close proximity to the Nature Area and Upper Pond may cause a potential conflict between uses.

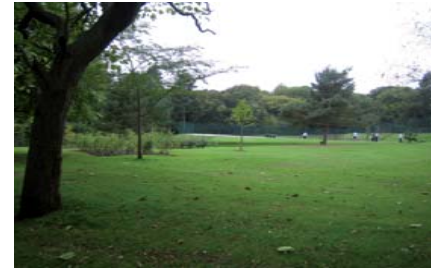
- 2. Location:** Grass lawn area opposite tennis courts and Park Attendant's hut
Appraisal: This area consists of a very gently sloping open lawn area, bounded by a dense screen of trees or shrubs on its eastern edge. The area lies opposite the popular and well used tennis courts, and opposite the Park Attendant's Office, both helping to 'self-police' a new play area. The area is partially screened from the main path, located to the south, by grass banks which would help soften any visual impact. However residential properties along Bisham Gardens would potentially overlook the site and this may cause planning/residential concerns.

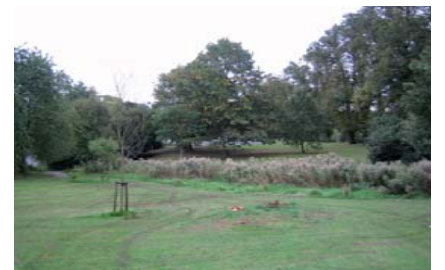
- 3. Location:** Steeply sloping grass area alongside open watercourse leading to Middle Pond
Appraisal: This is a narrow steeply sloping site which could make good use of the topography, and natural water-bodies of the Park. However access would be difficult and more or less impossible for less-abled children. Its central location on a steep slope would also mean the play area would be highly visible, particularly in winter, from many parts of the Park, and this could be seen as a negative impact within the historic landscape context of the Park. Drainage may also be an issue here.

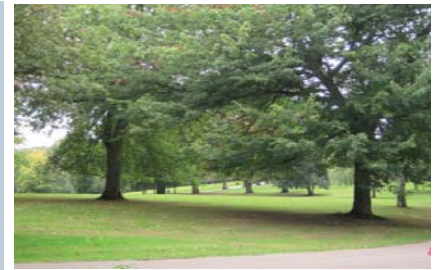
- 4. Location:** Grassy glade adjacent to Lower Pond, set amongst group of mature trees
Appraisal: This undulating grass area scattered with mature trees, is located on the lower bend of the mature Lime Avenue and gently slopes down to follow the edge of the Lower Pond, where a mature hollowed-out Oak tree stands as a key focal point of the area. The informal group of trees located on the upper slope of this area would form a beautiful sylvan setting for a natural play area. With the area 'sitting' in the lower section of the Park, intrusive views of the playground would be kept to a minimum. The site is also nearby to the Toddler/Junior playground, and is also well accessed from the Swains Lane and Dartmouth Park Hill Park entrances. Drainage may be an issue here, with signs of waterlogging.

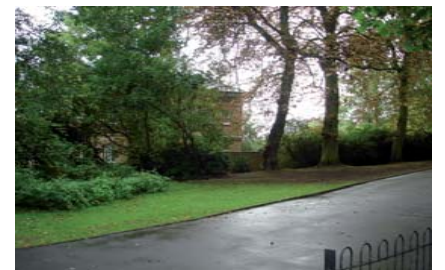
- 5. Location:** Section of southern boundary consisting of mature trees, grass and areas of shrubbery, adjacent to existing Toddler/Junior playground
Appraisal: This area lies alongside the existing Toddler/Junior playground and follows the edge of the Park's southern boundary with the Whittington Hospital (Highgate Wing) and Highgate cemetery. This area could be used to form a thin linear natural play area weaving in and out of the grass areas scattered with mature trees and denser area of shrubberies, where informal path lines have already been formed. In some sections, close to the Hospital, the ground drops steeply to the boundary fence, making access difficult. There also appears to be issues regarding boundary security with evidence of informal access via the Hospital and Park sites. The narrowness of some boundary stretches could also be a design constraint.
